# A Lighting Audit of The University of The West Indies St Augustine Campus

**Keywords:** Lighting audit, illuminance measurements, lighting designs, financial assessment, design simulation, implementation plans

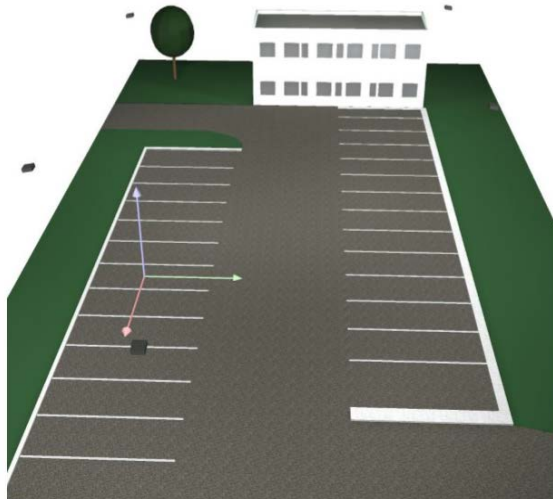
Figure 2. 3D Rendering for the SPEC Car Park

- 2) At *SPEC Car Park*, one 400 W metal halide lamp is used to illuminate the car park. This single fixture cannot properly distribute light evenly throughout the entire carpark, hence the uniformity ratio and the minimum vertical illuminance did not meet the recommended standard. The average horizontal illuminance was the only parameter that met the recommended level.

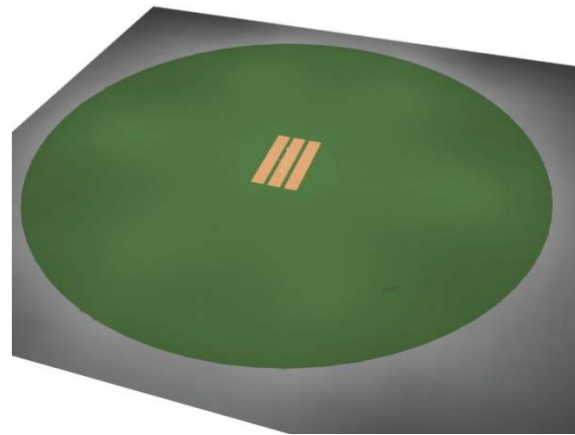
Figure 4. 3D Rendering of the SPEC Cricket Field

The initial evaluation of the infield showed that the uniformity ratio and the coefficient of variation met the recommended standard, however, the average horizontal illuminance did not meet the recommended standard for a class two cricket field. The outfield was then evaluated

using a reduced number of sample points since it was already established that the field did not meet all the recommended standards. A grid with each subsection having an area of forty square feet was used to evaluate the outfield. Analysis of the data gathered from measurements of the outfield showed that the lighting of the outfield did not meet any of the recommended standards.

$E_{avg}$	$E_{max}/E_{min}$	CV
<i>IES (2015) RP-6-15 Recommended lighting levels for Infield</i>	750	1.5	0.1
Design Infield Lighting levels	765	1.087	0.0242
<i>IES-RP-6-15 Recommended lighting levels for Outfield</i>	500	2	0.17
Design Outfield Lighting levels	603	1.8	0.142
