# A Road Collapse at Pont Cassé, Dominica: Hydrologic and Hydraulic Aspects

Gyan Shrivastava

**Abstract:** In the early morning (about 5:30 AM) of Friday 19th April 2013 a motor vehicle fell in a 13m deep and 25m wide ravine, which had rapidly formed across a major road, at a culvert crossing at Pont Cassé in the island of Dominica  $(15^{\circ}N, 16^{\circ}W)$  in the Lesser Antilles. There were intermittent heavy rains in the preceding three days, and particularly during the preceding twenty-four hours. About 400 mm of rain is believed to have fallen on the catchment upstream of the culvert crossing. This accident unfortunately led to the death of two persons. This technical note, based on a site visit during 5th to 7th May 2013, first outlines the hydrologic and hydraulic setting of the road collapse, as well as the unavailability of event specific hydrologic data. It concludes – essentially using heuristics, judgment and transposition - that the probable causes of the road failure were twofold - firstly, a flash flood, arguably, with a return period in excess of 100 years, and secondly, an inadequate maintenance of a concrete culvert in a terrain prone to slope instability. I

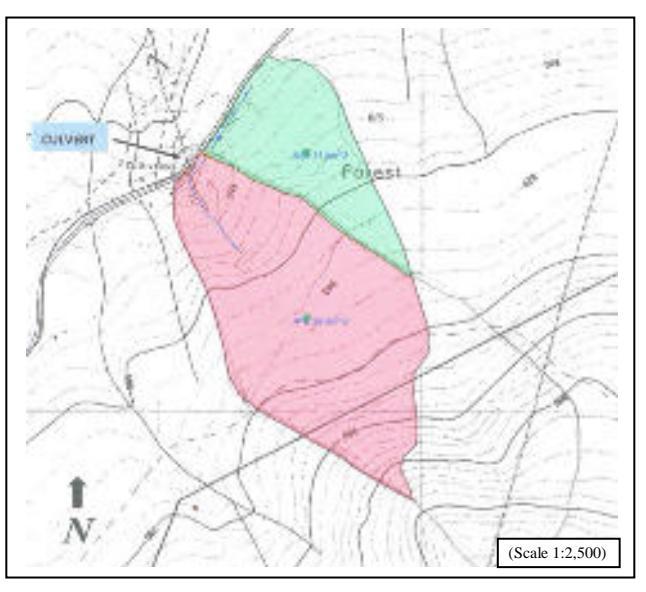
Figure 2 shows that the catchment upstream of the road breach is approximately 0.5 km<sup>2</sup> and is almost entirely forested (Google Earth). It seems to have an average slope of 9% and a time of concentration,  $t_c$ , of about 17 minutes. There is a 3:1 ratio between the Annual Rainfall at Pont Cassé and Melville Hall (US Army Corps of Engineers, 2004).

Figure 2. Estimated catchment area upstream of the road collapse Source: Cooper (2013)

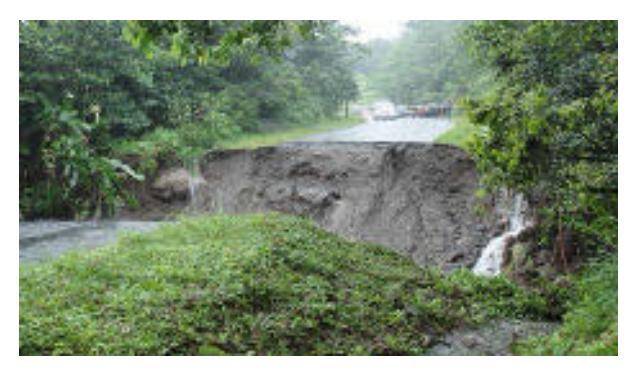
Figure 3. A photo showing a collapse of a road at Pont Cassé

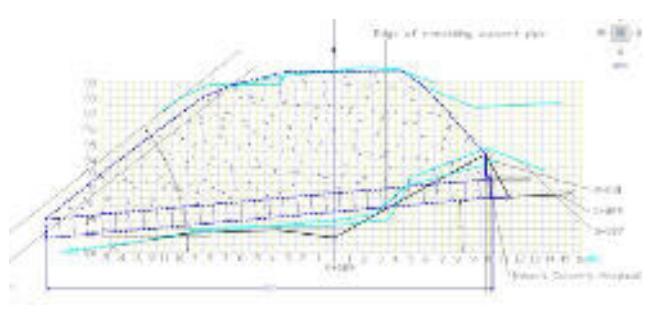
Figure 5. Reconstructed Road Cross Section Source: Gay (2013)

Hydraulic analyses under inlet control with a headwater depth at the road crest level (i.e. 8m) gave a peak discharge, of the 1.2m diameter culvert, as  $11.3m^3s^{-1}$ , entrance velocity of 13 m/s, an inlet velocity of 10.5 m/s running 95% full, an outlet velocity of 10m/s with culvert flowing full. Such a velocity regime can impart a force (approximately 50 kNm<sup>-2</sup>), which is about half of the atmospheric pressure at sea level on a dislocated/exposed culvert joint.

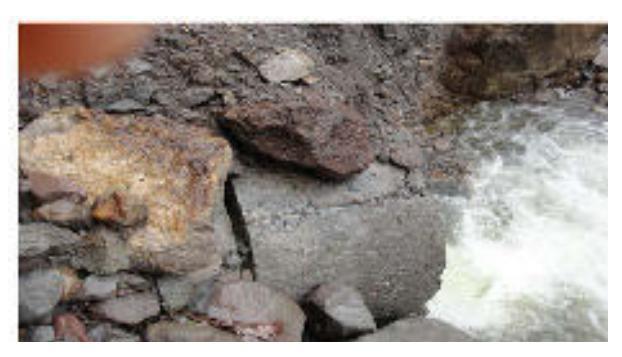
The mechanism of road failure remains open to question. On one hand, there is a possibility of a peak flow exceeding the culvert capacity. This can cause failure due to combined overflow erosion and progressive jet erosion at culvert joints (through joints dislocated by traffic vibration, slope instability or seismic activity over time) commencing at the outlet (see Figure 6). On the other hand, if the culvert capacity was not exceeded, there is the possibility of failure entirely due to progressive jet erosion of dislocated culvert joints commencing at the outlet. One interim conclusion that can be made from these perspectives is that, irrespective of the failure mechanism the choice of reinforced concrete box culvert (FHWA, 2005) is clearly superior for a replacement structure.

Figure 6. A photo showing dislocated culvert joints

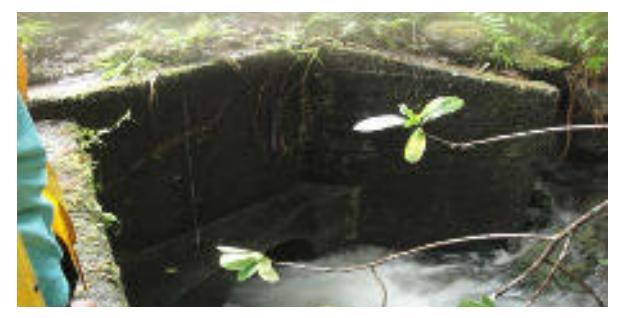
Figure 8. A photo showing the culvert inlet

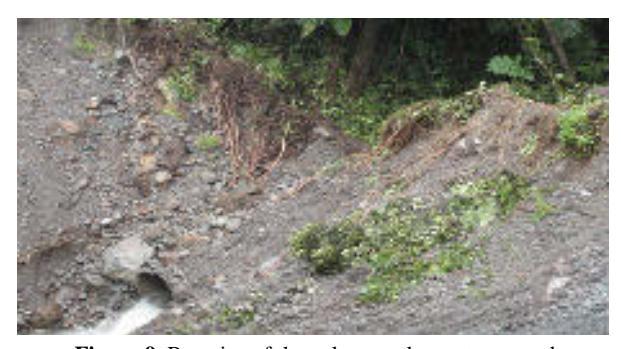
Figure 9. Remains of the culvert at the upstream end
