Assessment and Reconstruction of Bridges in Trinidad and Tobago

Ian Khan-Kernahan

Department of Civil and Environmental Engineering, The University of the West Indies, St Augustine, Trinidad and Tobago,
West Indies

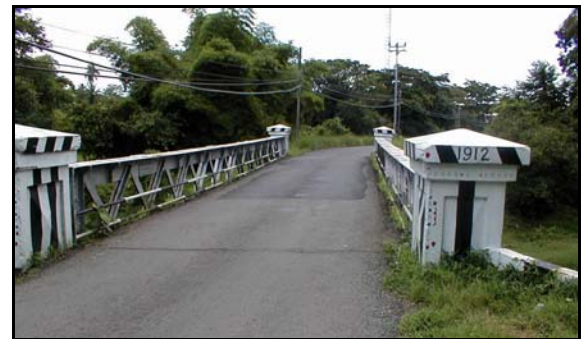
Figure 1. Plymouth Bridge (Tobago)

disrepair. There was a preponderance of short span bridges, up to 9 metres, which reflects the location and rural nature of the project roads. A typical obsolete single lane colonial truss bridge is shown in Figure 1. The obelisk indicates it was commissioned in 1912.

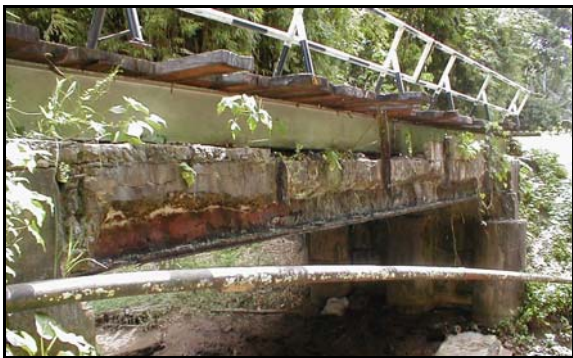
Figure 2. B2/1 La Lune

Some of the bridge decks had several maintenance interventions since they were constructed and exhibited a wide range of engineering awareness in the treatments. There were examples of properly designed reconstruction solutions, as well as ad hoc emergency repairs of questionable effectiveness. There were several examples of the original bridge decks being overlain by newer ones, presumably to save on temporary formwork or deck supports. Figure 2 shows a typical example.

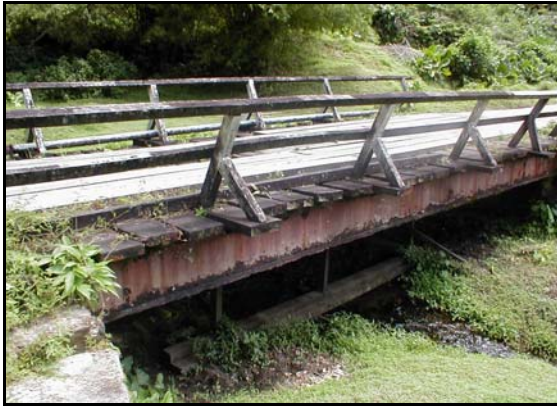
Figure 4. B2/35 Paria Main Road

Figures 4 to 9 illustrate some of the bridges before and after construction. The bridge in Figure 4 had timber beams and one (1) steel edge beam. The timber beams were propped, presumably to avoid collapse under the passage of heavy loads. The new bridge is shown in Figure 5. The Single-Single Mabey bridge in Figure 6 was installed when the original bridge got washed away a few years earlier. The extremely poor alignment of the

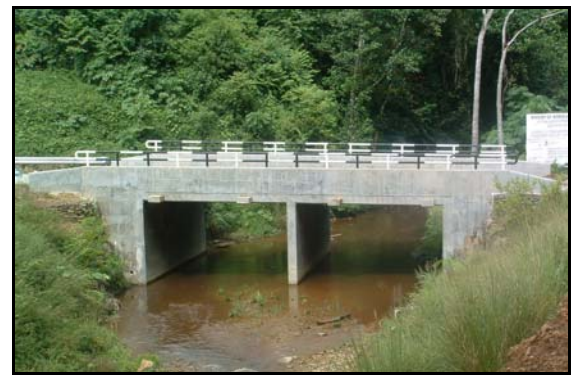
Figure 7. Replacement : 6m-6m Twin Box

roadway is easily seen. A Twin-Box now stands in its place (see Figure 7). The riveted steel bow arch in Figure 8 was found to be in very poor condition. Many of the transoms were heavily corroded, to the extent where large holes had appeared. This bridge was replaced by a 25m span semi-integral bridge (see Figure 9).
