# A Road Collapse at Pont Cassé, Dominica: Hydrologic and Hydraulic Aspects

Gyan Shrivastava

**Abstract:** In the early morning (about 5:30 AM) of Friday 19th April 2013 a motor vehicle fell in a 13m deep and 25m wide ravine, which had rapidly formed across a major road, at a culvert crossing at Pont Cassé in the island of Dominica  $(15^{\circ}N, 16^{\circ}W)$  in the Lesser Antilles. There were intermittent heavy rains in the preceding three days, and particularly during the preceding twenty-four hours. About 400 mm of rain is believed to have fallen on the catchment upstream of the culvert crossing. This accident unfortunately led to the death of two persons. This technical note, based on a site visit during 5th to 7th May 2013, first outlines the hydrologic and hydraulic setting of the road collapse, as well as the unavailability of event specific hydrologic data. It concludes – essentially using heuristics, judgment and transposition - that the probable causes of the road failure were twofold - firstly, a flash flood, arguably, with a return period in excess of 100 years, and secondly, an inadequate maintenance of a concrete culvert in a terrain prone to slope instability. I

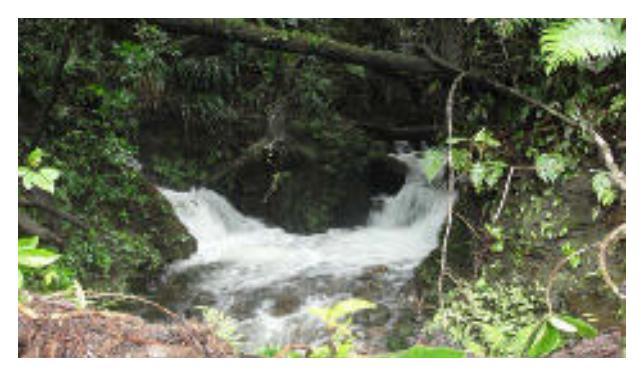
Figure 4. The stream at Pont Cassé

It is against the foregoing background, that this report estimates, as a first approximation, the likely return period (probability of occurrence) of peak flow which occurred during the breach of the road on the morning of Friday 19<sup>th</sup> April 2013. It does so by a combination of Global and Regional Flood Frequency Analyses (DHV Consultants, 1998, Meigh et al., 1997). Specifically, Mean Annual Flood (MAF) is estimated first and it is then scaled up for higher return periods. For estimating MAF a regression equation for West Africa ( $\leq 8^{0}$ N) is selected, since in the author's experience its hydrology is similar to that in the Caribbean. This perhaps should not be surprising, since Caribbean Weather Systems normally originate off the coast of Africa. The MAF equation includes the catchment area (AREA) as well as the Average Annual Rainfall (AAR), and gives an MAF of approximately 2  $m^{3}s^{-1}$  for the stream at Pont Cassé (see Figure 4) for an  $AREA = 0.5 \text{ km}^2$  and AAR of 6,645mm.

Regional correlation with the Global Frequency for the stated region in Africa shows that a 50 year return period peak flood is about two times the MAF and a 100 year peak flood is about three times the MAF. Subsequently, comparison with the hydraulic capacity of the failed culvert indicates a rainstorm of return period  $\geq$ 100 years.
